INSPECTION REPORT

General Cargo International Terminal

JMT Project No: 18-02353

Submitted to:
CLEVELAND - CUYAHOGA COUNTY PORT AUTHORITY

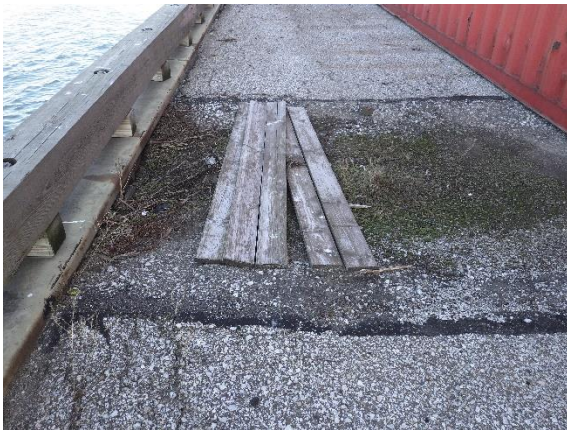
Fig. 1 - Pavement settled and damaged (drainage outlet)

Pavement Repairs = \$ 26,400

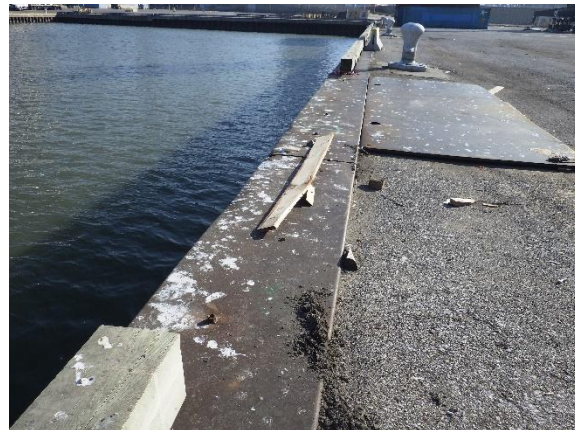
Fig. 2 – Break in timber curbing

Timber Curbing = \$ 12,600

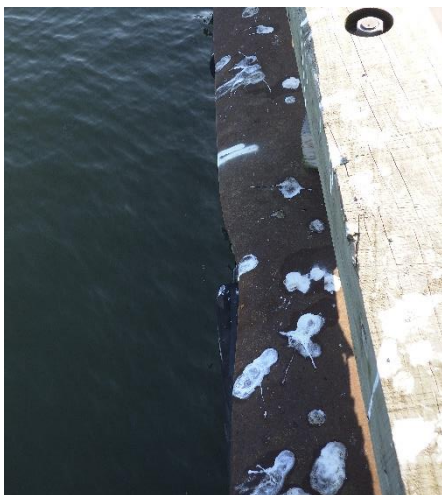
Fig. 3 – Damaged pile cap

Pile Cap Repairs = \$ 33,700

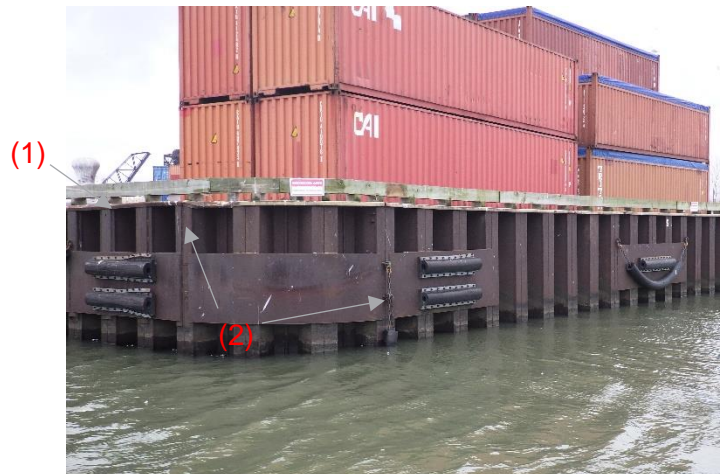
Fig. 4 – Damaged fender (1) and failed connection (2)

Fender System Repairs = \$ 95,200

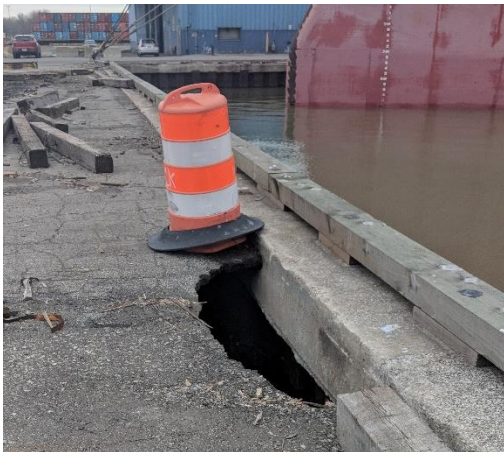
Along the south headwall between Docks 24 and 26, there is a 24” outfall with corrugated metal pipe (CMP) that has deteriorated behind the bulkhead causing loss of backfill material and pavement as shown below.

Fig. 5 – Sinkhole at CMP Outfall

The Port will be completing repairs on the outfall shown in Figures 5 and 6 under a 2019 repair contract.

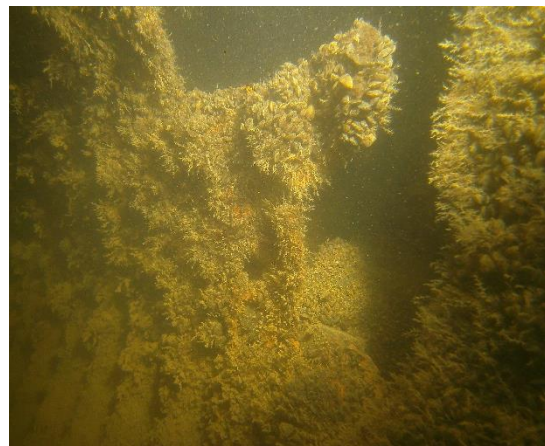
Fig. 6 – Section loss at outfall (underwater)

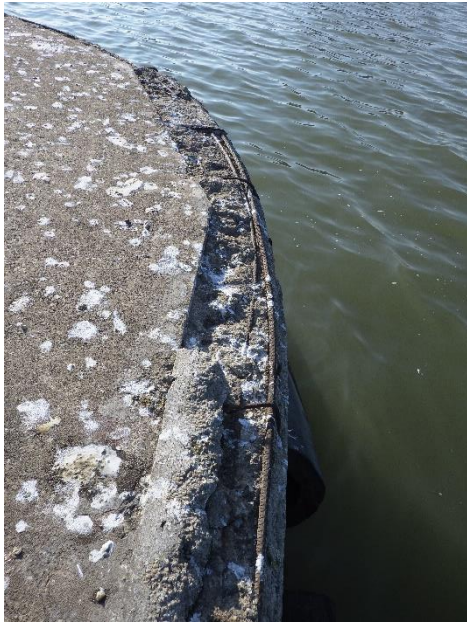
Fig. 7 – Deteriorated pile cap

Concrete Pile Cap Repairs = \$ 1,087,100

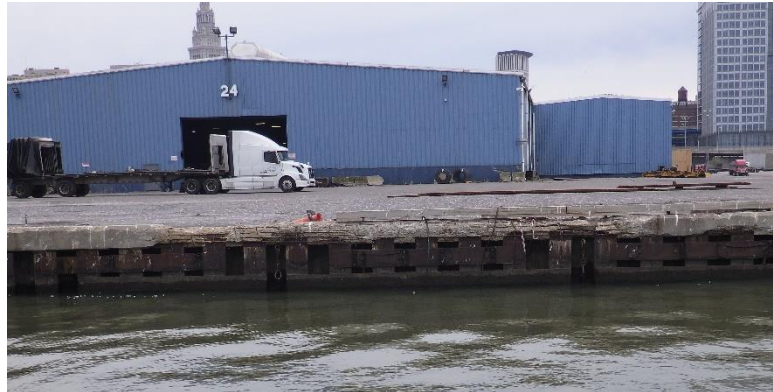
Fig. 8 – Deteriorated pile cap and break in timber curbing

Timber Curbing Repairs = \$ 14,400

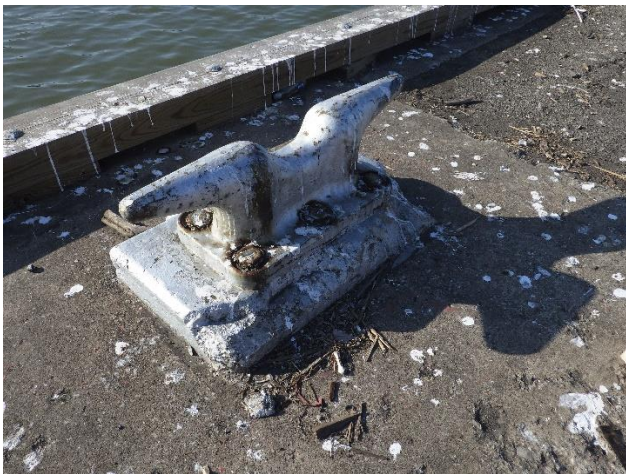
Fig. 9 – Deteriorated mooring cleat foundation

Mooring Bollard Repairs = \$ 100,500

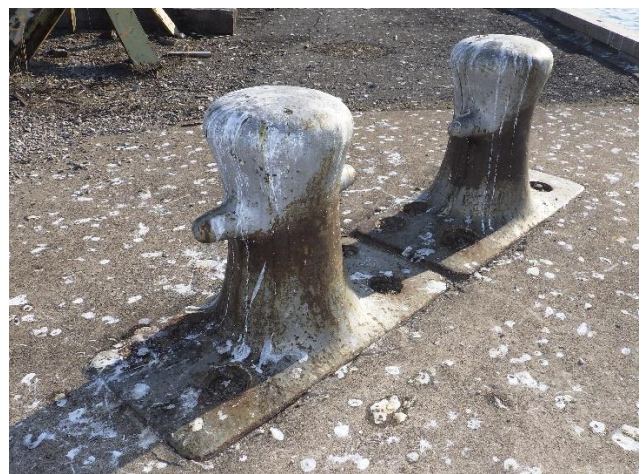
Fig. 10 – Corroded anchor bolts

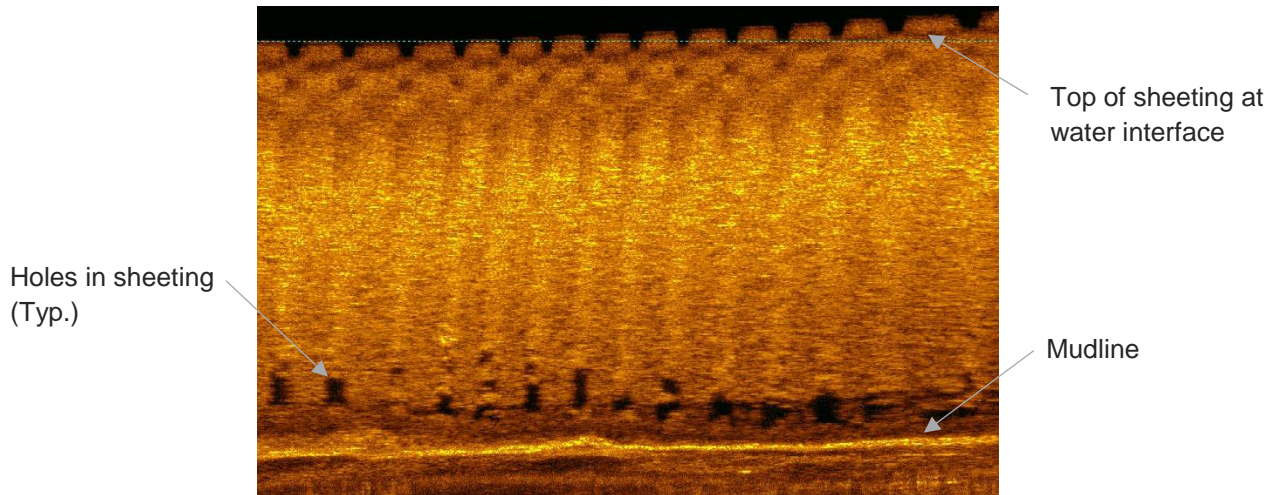
the plate so that the sheeting thickness could be obtained. Steel thickness measurements obtained on Dock 26 East exhibit minimal section loss. However, there are numerous locations of section loss along the mudline on Dock 26 West that were identified in the sonar scan (image below) and field confirmed in four locations.

Fig. 11 – Holes along mudline of Dock 26 West

There are approximately 58 locations over 550' of bulkhead on the west dock that are similar to the holes in Figure 11. Most of the holes are along the mudline and there are a few that are close to mid-height of the exposed sheeting. The first area of section loss was noticed 130' from the south end of the dock. From that point to the north end of the dock they are sporadically located with a high concentration around the mid-length of the dock and the north end, 400' and 590' from the south headwall respectively. The average hole size is 1.5' x 1.0'. Within this area, there was a repair project completed in 1999 to strengthen a section of wall, approximately 40' in length that was deflected outward at the mudline. The fact that the deflection was at the mudline indicates that the failure is at or below the mudline opposed to a top surcharge load or tieback failure. Below is a plan view detail of the repair, note the mention of "punctures, rips and tears" in the sheeting.

Given the quantity of breaches along the west dock, the bulkhead is in poor condition. On average, the dock as an infrastructure asset is in marginal condition. There are a high number of repairs required currently on the fender system and timber curbing, however these items might be replaced with the replacement of the existing bulkhead. Quantities for each asset that require repair or replacement are summarized in the table below.

Sheet Piling Bulkhead = \$ 3,525,300

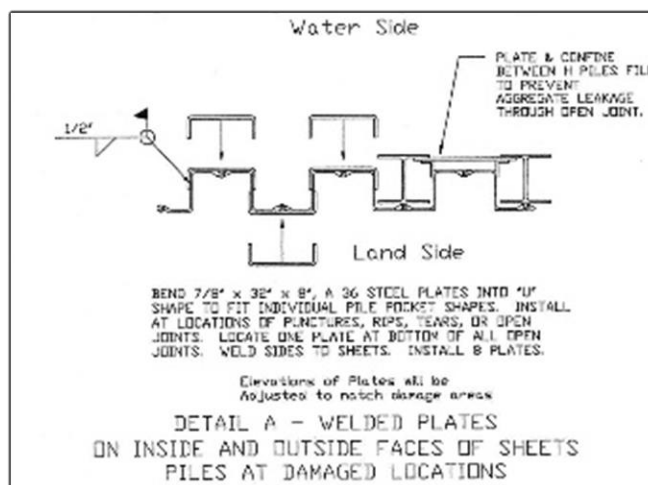
Fig. 12 – Plan view of 1999 sheeting repair

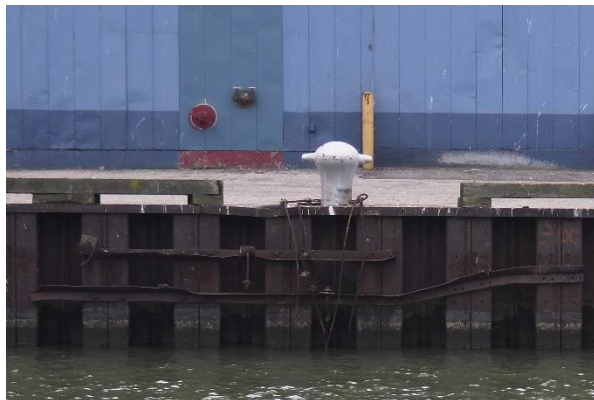
Fig. 13 – Damaged fender system

Fender System Repairs = \$ 531,300

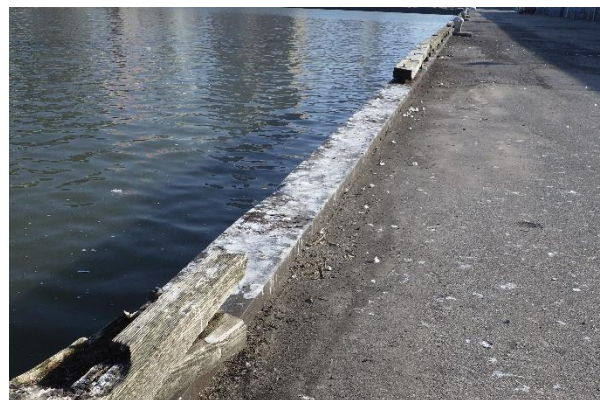
Fig. 14 – Break in timber curbing

Timber Curbing Repairs = \$ 45,600

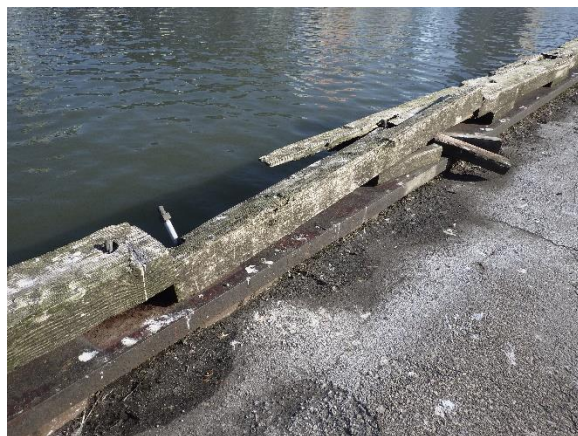
Fig. 15 – Damaged timber curbing and settled pavement

Pavement Repairs = \$ 26,200

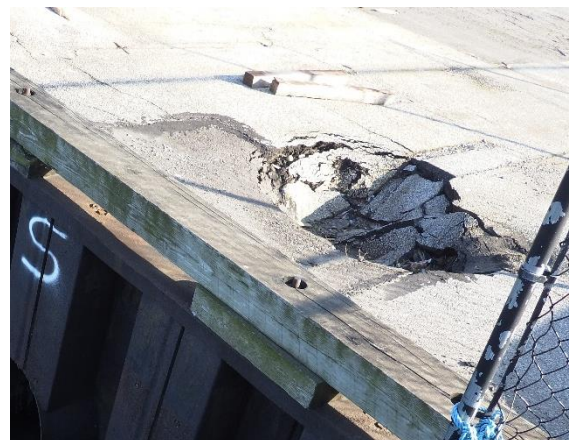
Fig. 16 – Sink hole behind south headwall

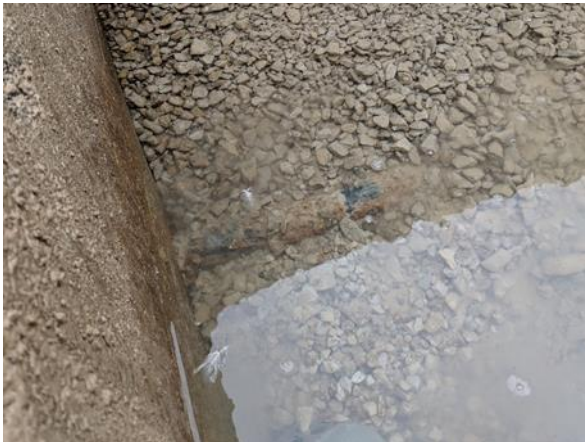
The tieback system is a critical component for the wall stability, therefore it was exposed behind the bulkhead to inspect and verify the existing condition. Based upon available records, this is the first inspection to uncover the tieback system for evaluation. The condition of the steel tieback, waler and concrete deadman was in very good condition with little to no section loss observed. The elevation of the tieback system is approximately 1'-2' below the groundwater elevation (at the date of exposure, January 2019). Below are photographs of the exposed tieback and top portion of the deadman. Based upon the condition of the system, it is not warranted to complete an inspection of the tiebacks until either a repair of the bulkhead is required or the system is still in use in 10 years, 2029.

Fig. 17 – Tieback and Deadman Exposure

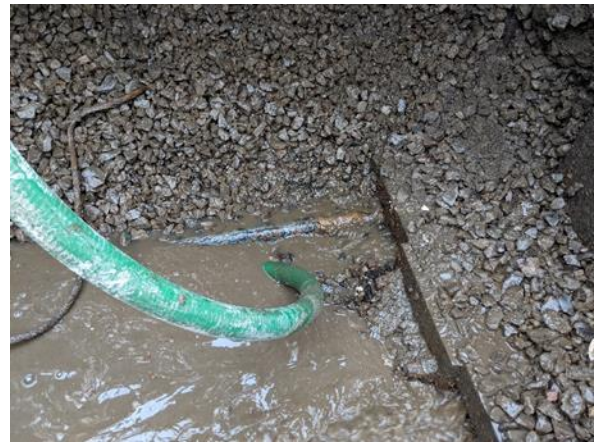
Fig. 18 – Tieback and Waler Exposure

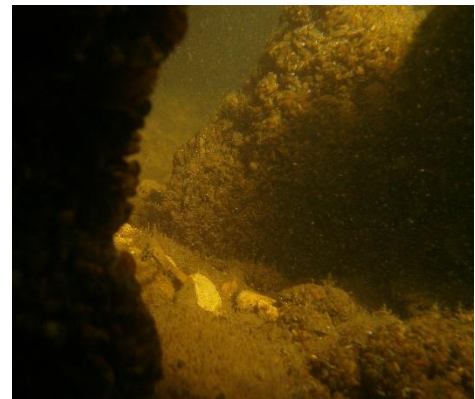
Fig. 19 – Section Loss in CMP Outfall

the 12" CMP outfall at the North end of the dock has deteriorated much like the outfall between Docks 24 and 26.

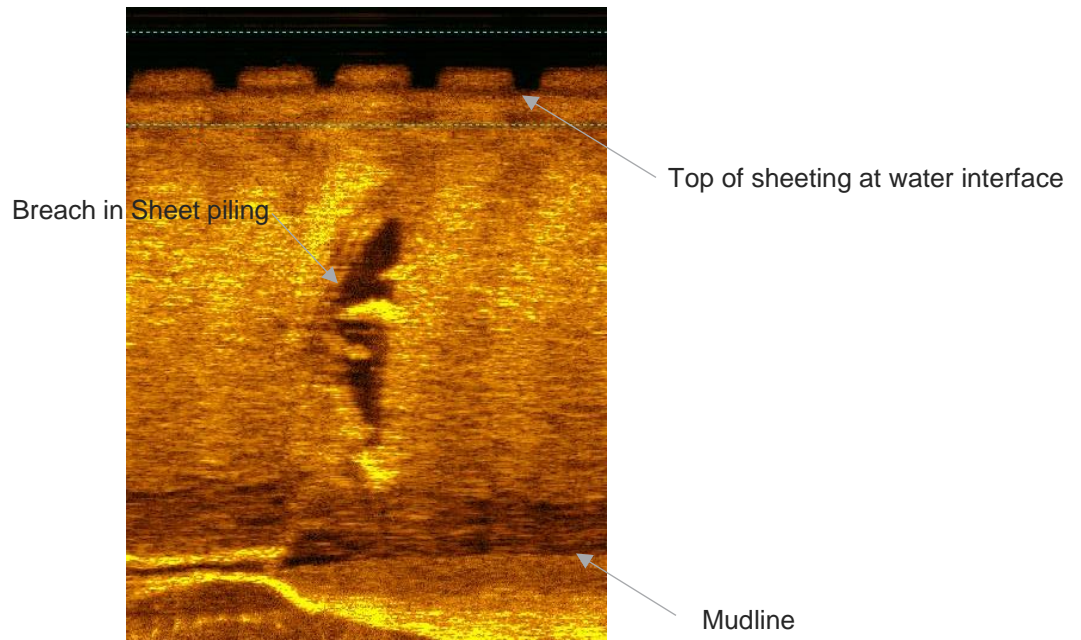
Steel thickness measurements obtained on Dock 28 exhibit minimal section loss. However, there is one relatively large breach in the bulkhead 80' south of the north corner. The size of the breach is approximately 10' x 2' at the maximum ellipsoid shape of the opening (see Figure 20 below) and there is a sinkhole behind the bulkhead in this location that is approximately 80 sf. A repair was made behind the breach by installing a line of sheet piling, however the ends of the sheet piling run were not closed or sealed. The open ends allow backfill to escape and creates a void behind the wall and depression in the asphalt pavement. The Port will be backfilling this area as needed. Additionally, the walls of

Fig. 20 – Breach in Dock 28

Bulkhead Sinkhole Fill = \$ 13,500
