VISUAL INSPECTION/EVALUATION REPORT
OF
Crane Runway, Warehouse A
Middle Bay

Prepared by Osborn Engineering
October 2021
Cleveland, Ohio

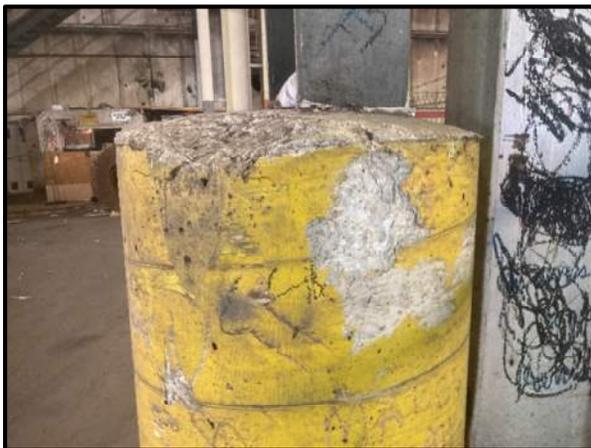
Column Lines, east and west, were inspected as described above from both ground level and the manlift. The columns had multiple areas of impact damage typically, and concrete protection jackets on selected columns, most likely as determined from ingress/egress passageways and travel of heavy equipment in specific bays (Figure 3).

Figure 3 – Typical concrete encasement

2. The cross-bracing members should all be replaced.
3. Repair concrete-encased members as needed, and determine long-term Capital Plans for placing this detail at all columns as follows:

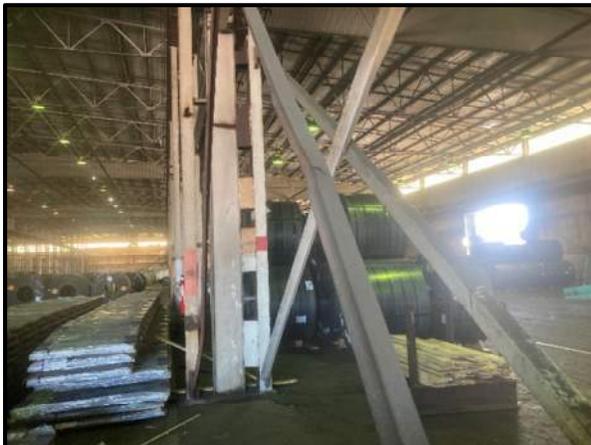
Figure 5 – Typical cross-bracing

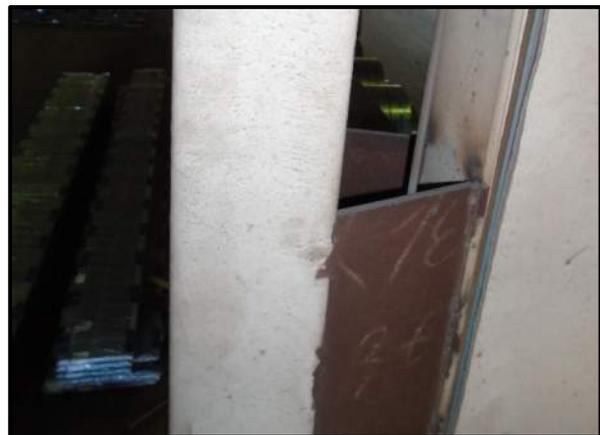
Figure 6 – Typical plates welded to column flanges

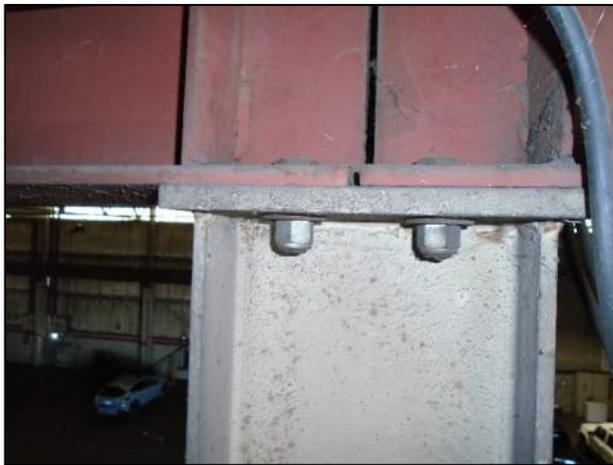
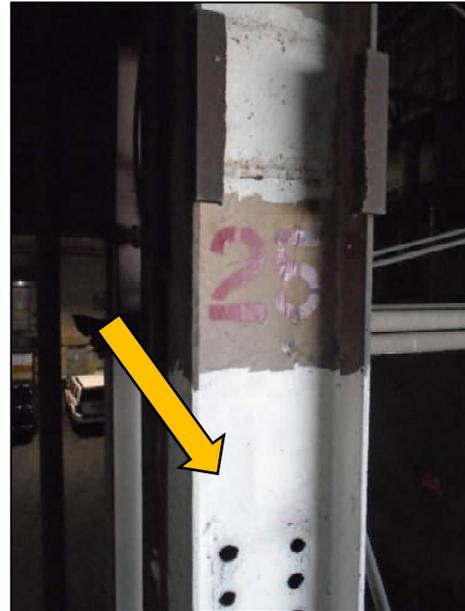
Note previously drilled holes
in web of column

Figure 7 – Typical bearing area and upper column (left) and holes in web (right)

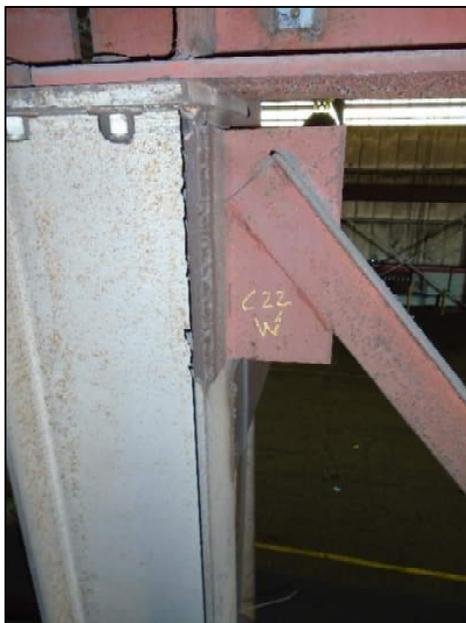
Figure 8 – Typical gusset plate at column

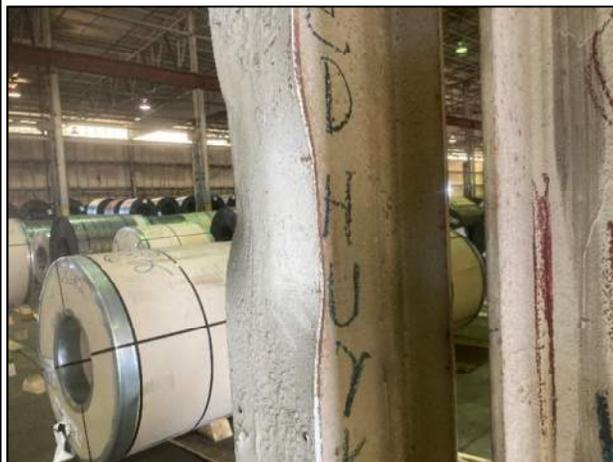
It should be noted that POC management has placed a temporary stop block at/near column C20 as the west column has multiple impact dents up to 1½” and is deflected approximately 3” off center and up to five feet above the base plate. The crane rail currently stops at or near column line 19. In addition, most of the cross-bracing had multiple kinks, dents or impact damage throughout the elements or members. The columns also had typical channel sections welded on the backsides of each in third segments, or distinct points along the webs (Figure 4).

Figure 9 – Impacted column

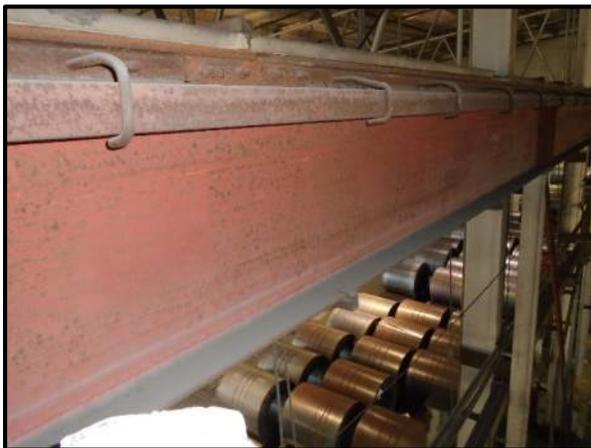
The W-beam sections, channel bases, crane rails and all bearing areas and connections, east and west, were inspected as described above from the manlift. The beams overall were in satisfactory condition with minor issues such as pinpoint rusting, corroded areas, thin or faded coatings, dirt and debris lying on lower flanges and small improper seating issues at the tops of columns. The seated channels, lying on their sides to carry the crane rails, were in a similar satisfactory condition with dirt and some corrosion beginning.

Figure 12 – Typical beam and rail condition

1. All horizontal surfaces had dirt, debris, grease, oil, corrosion flakes and metal shards on them. Good maintenance practices recommend that these areas (flanges, seats and bearings, rail splices and plates) be cleaned by power washing or equal, especially prior to inspections so that cracks, deficiencies and other elements can be clearly visualized. After this has been accomplished, steel areas should be cleaned and repainted.

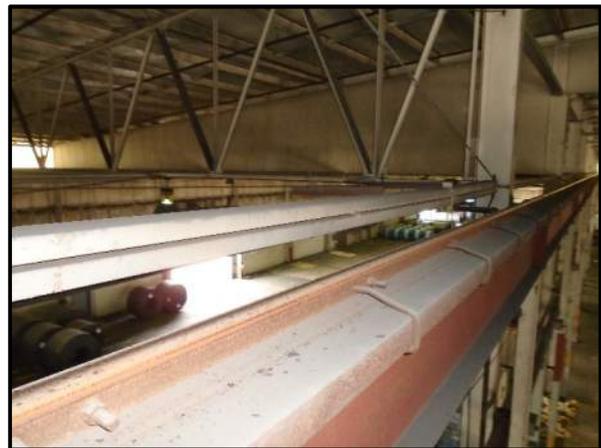
Figure 13 – Typical channel section with crane rail

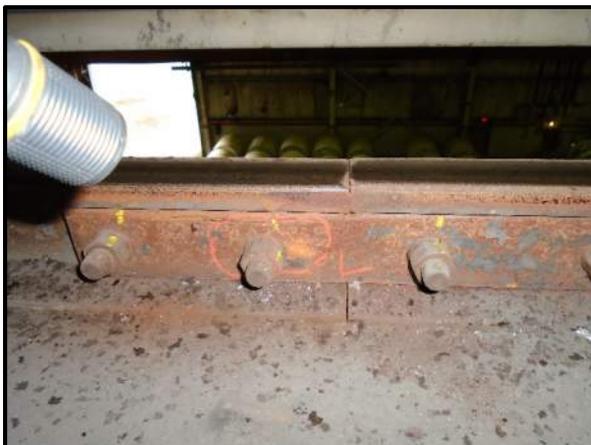
Figure 14 – Match-marked bolts at splice plate

6. Tighten all loose bolts to the proper torque and place steel or neoprene shims as needed.
7. Depending on the frequency of use, the available capacity of the crane rails should be determined. In addition, all superstructure (girders) and substructure (columns, GP's, knee braces, diaphragms and supporting units) elements should receive a load rating. Fatigue in these types of elements is a major concern and should also be investigated.

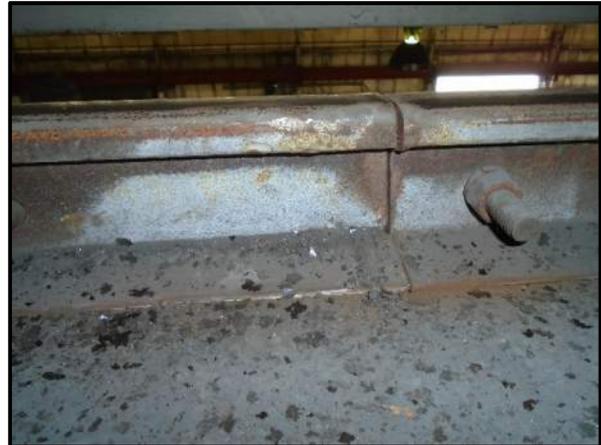
The crane rails overall were also in satisfactory to fair condition. There were some areas of loose hold-downs or anchors, some splice plate bolts were loose, and in a few areas the rail was slightly misaligned. In a few areas the crane rail had a small gap below it between the rail and channel section. Finally, in one (1) area, the splice plates for the crane rail seemed to be missing – W12-13 (Figure 15).

Figure 15 – Missing splice plate at W12-13

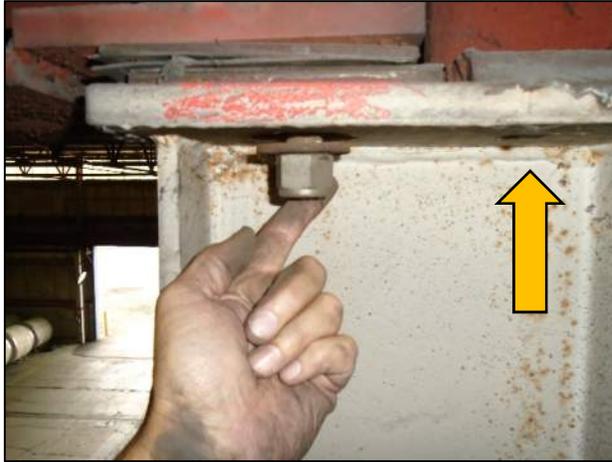
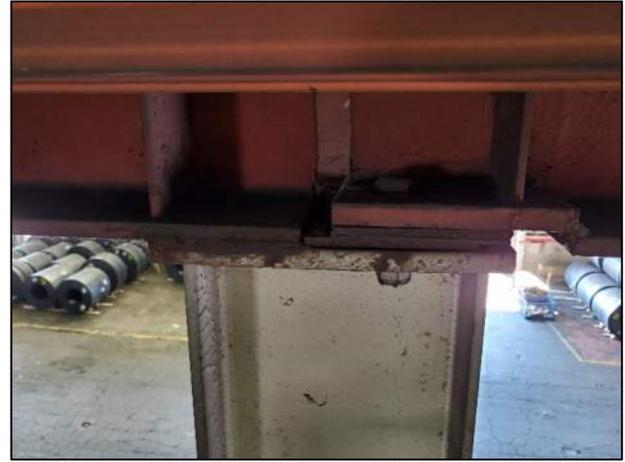
Figure 16 – Loose bolt and missing bolt (left) and bearing connection detail (right)

Lastly, in regards to the end connection detail shown in Figure 16 and sketch provided in Appendix E, our engineers are concerned about possible cracking of the welds due to the intersecting welds between the flange and web and the direct tension on the flange welds of this detail. It appears to be an odd detail to allow expansion for the crane rails while maintaining a constant top of steel for the crane rails to run on/over. If possible, a spliced section across the bottom flange with a longer plate to transfer the flange force in shear rather than tension could be used. If more information or a sketch is required, our engineers would be happy to provide this detail.

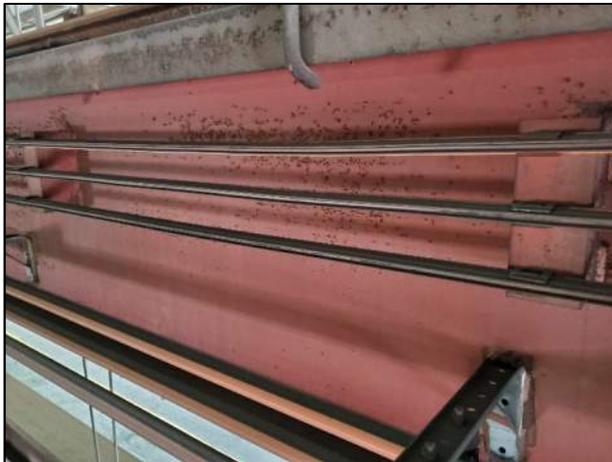
Figure 17 – Typical utility hangers at west

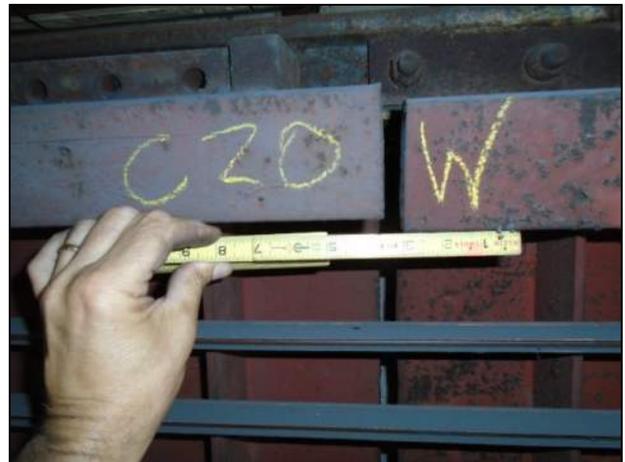
Figure 18 – Offset of channel sections, C20W

4. After repairs are completed to columns and the beam/rail sections, remove the temporary stop located near C20.
5. Align any channel members that are distorted or out-of-alignment.
