# WARREN ROOFING & INSULATING CO.

Subject: Roof Assessment

BUILDING A-

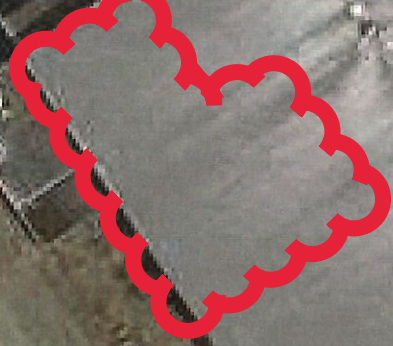
BUILDING A

2012 storm  
damage area

2020 storm  
damage area

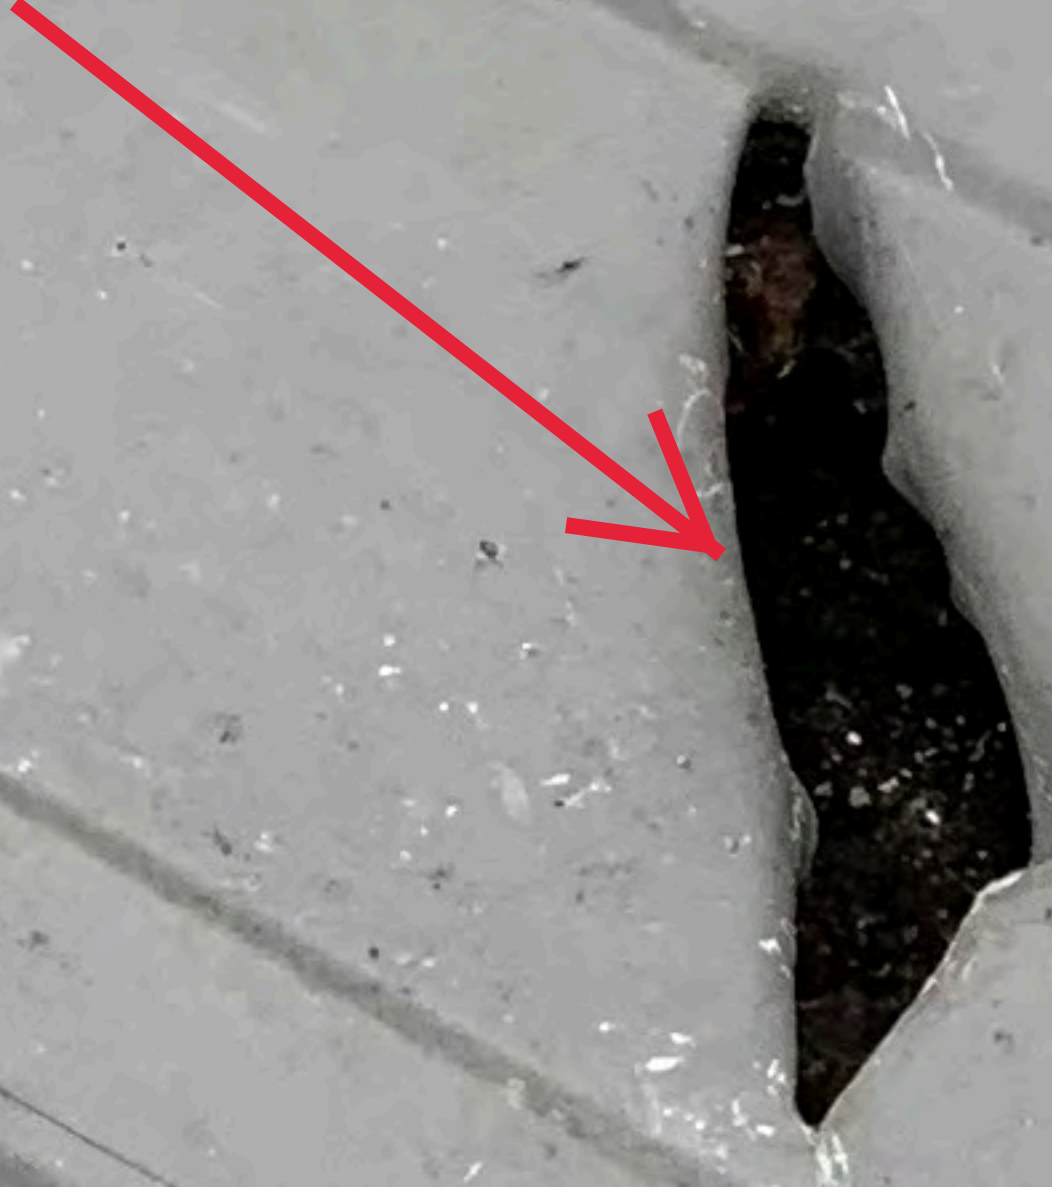
Cut in existing panel.

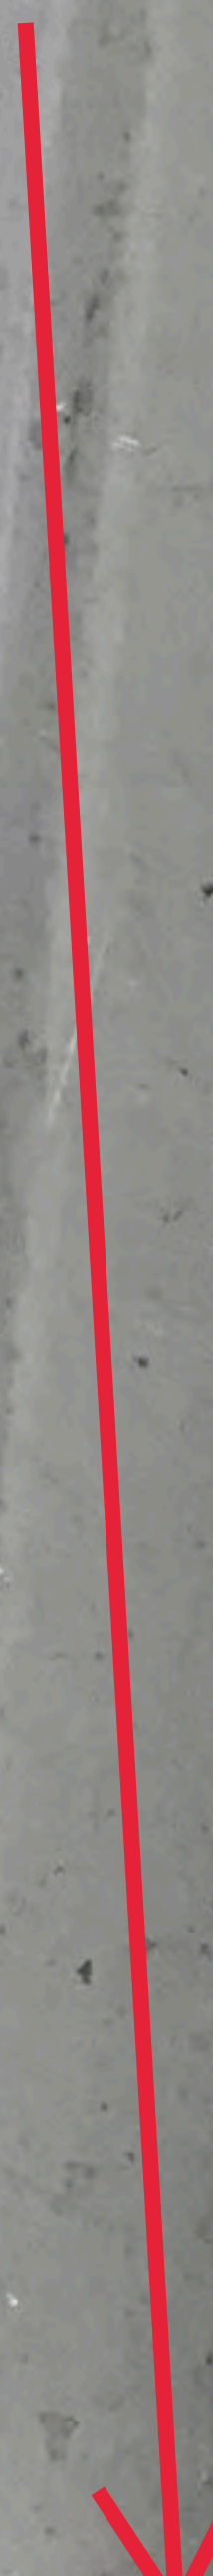
Holes penetrating panels.

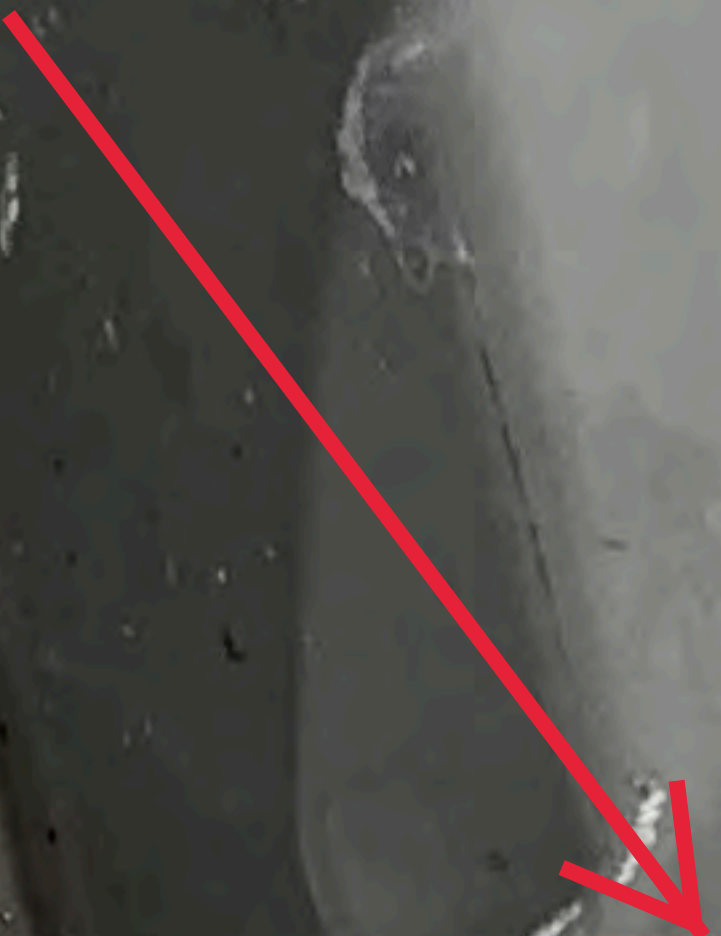
Standing seam rib  
crushed.

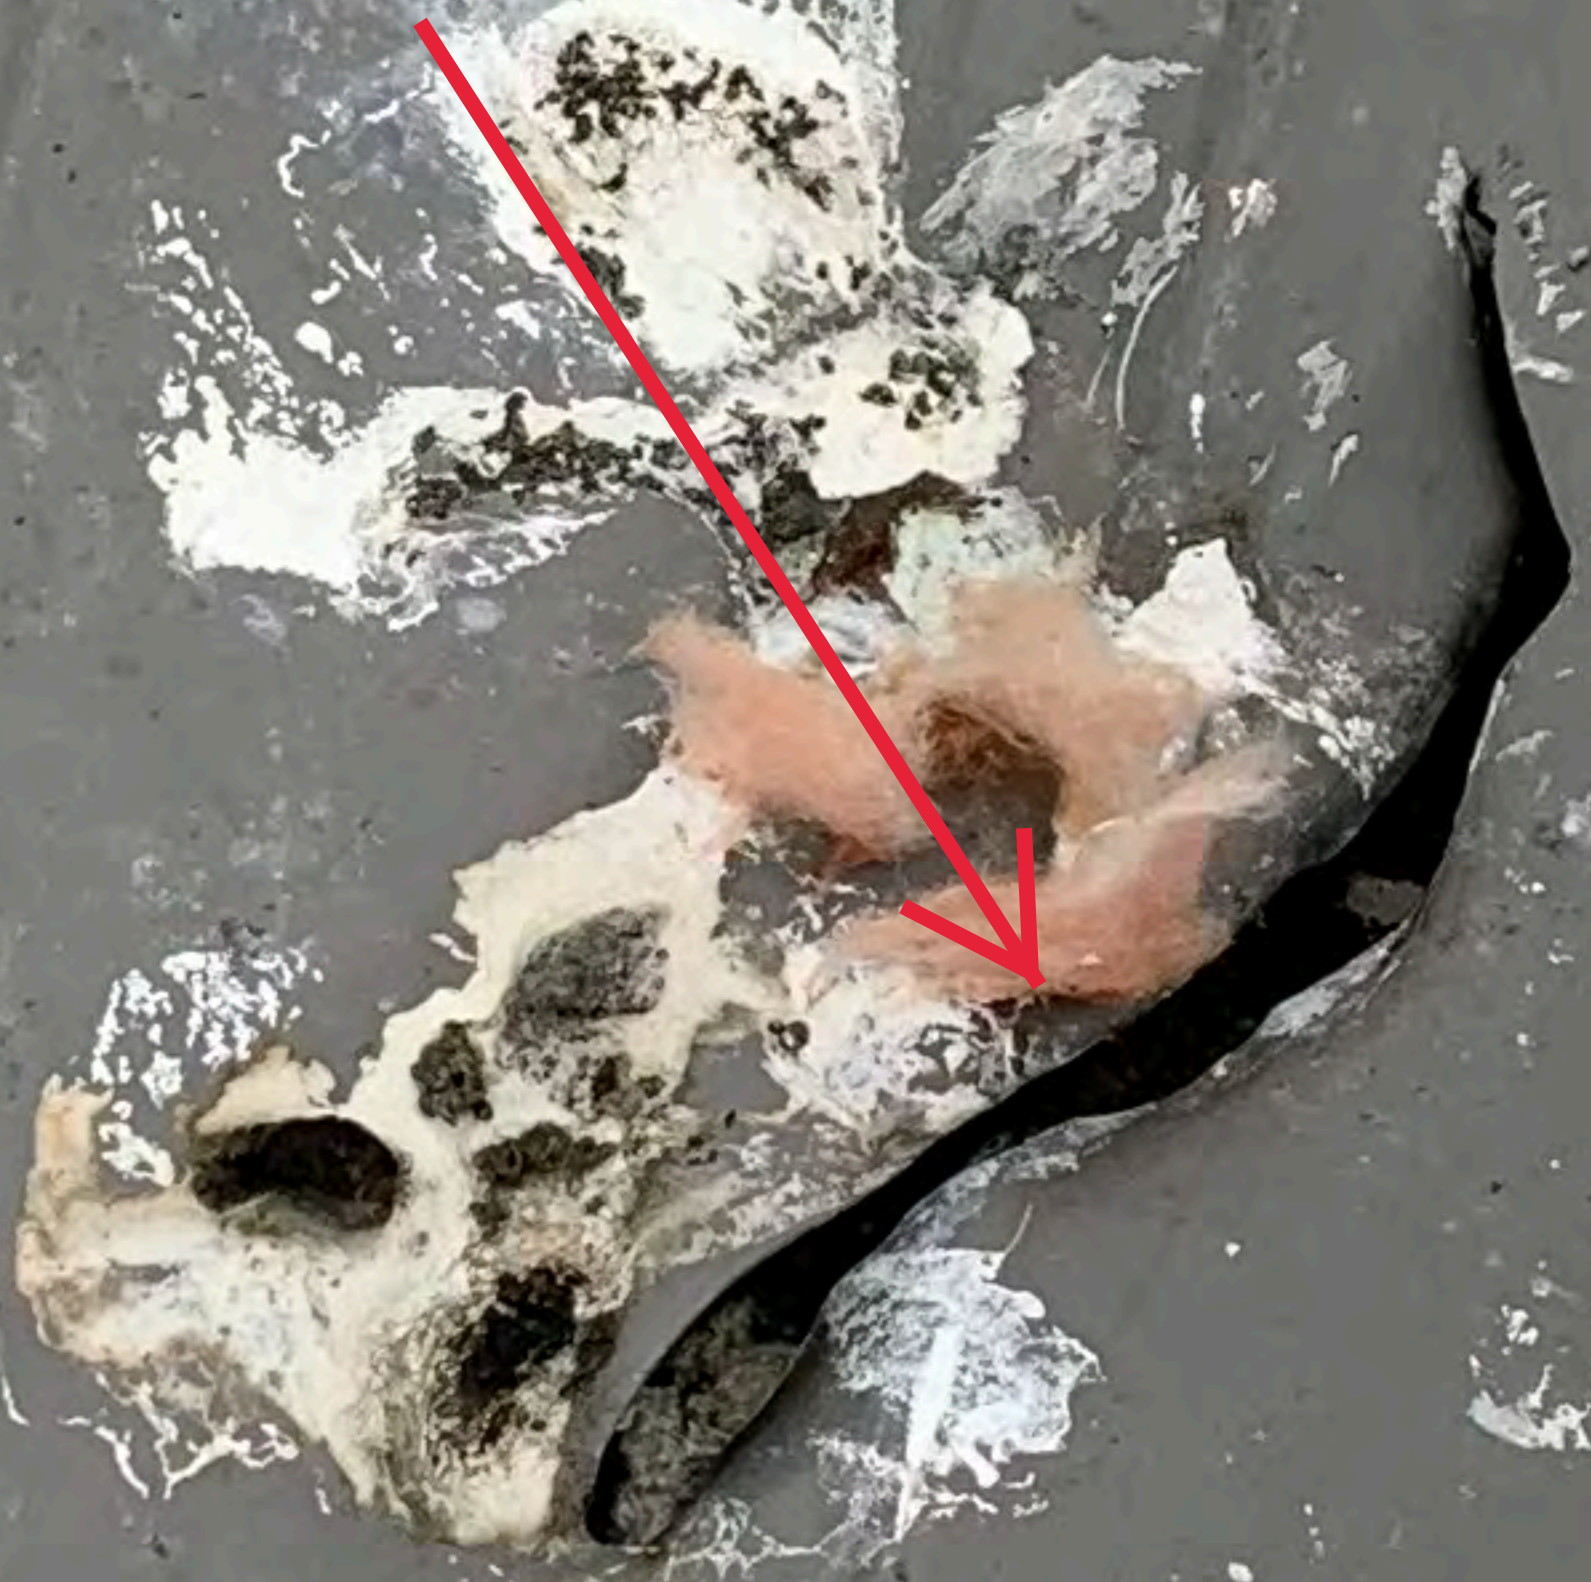
Damage from most recent wind event.

We recommend adding fasteners to the steel bar joists at the leading edge to help prevent further wind damage. Budget \$20,000.00.

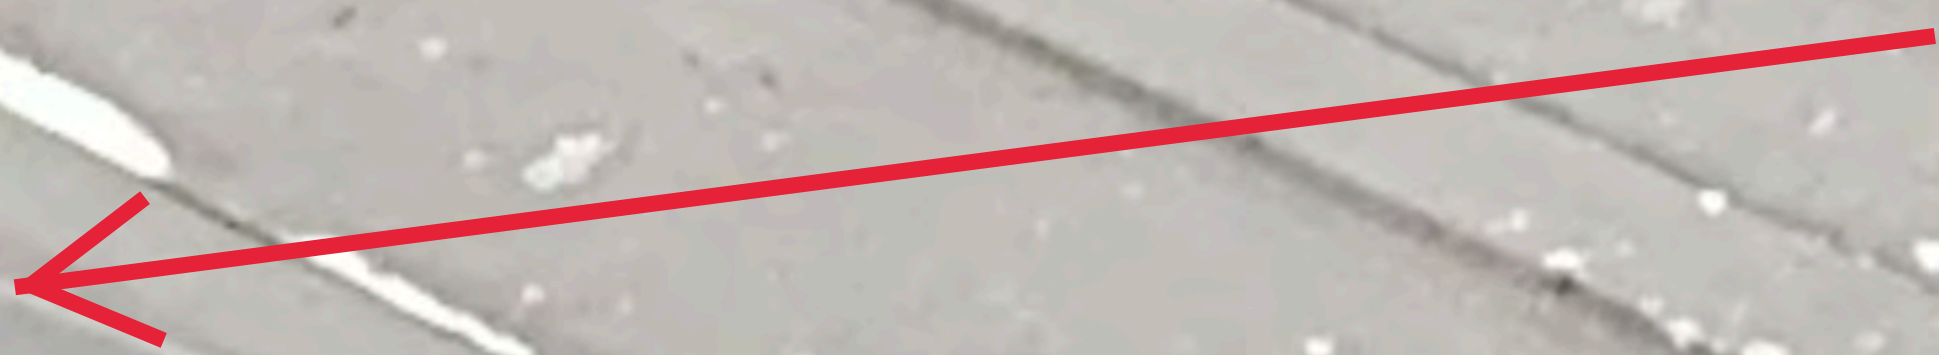
Damaged standing  
seam rib NE side.
