VISUAL INSPECTION/EVALUATION REPORT
OF
Crane Runway, Warehouse A
Middle Bay

Prepared by Osborn Engineering
October 2021
Cleveland, Ohio

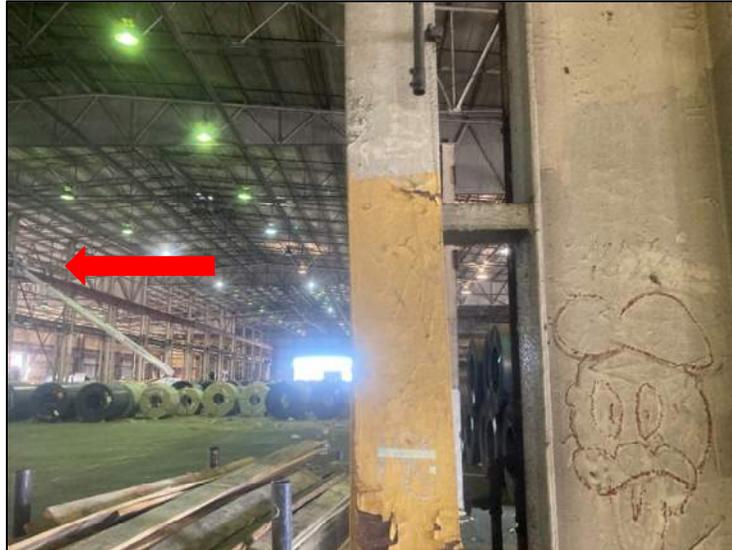
Figure 1 – Typical work area and column lines

The Middle Bay was inspected from both east and west column lines as denoted above. Figure 1 shows a typical area where equipment, lumber, steel coils and general utility, power lines/wires were encountered during the inspection. The columns and cross-bracing were inspected from the ground and visually using binoculars when needed and up to approximately fifteen feet (15'). Additionally, the Snorkel manlift was used to gain access to the beam lines, crane rails, bearing areas and upper portions of the columns.

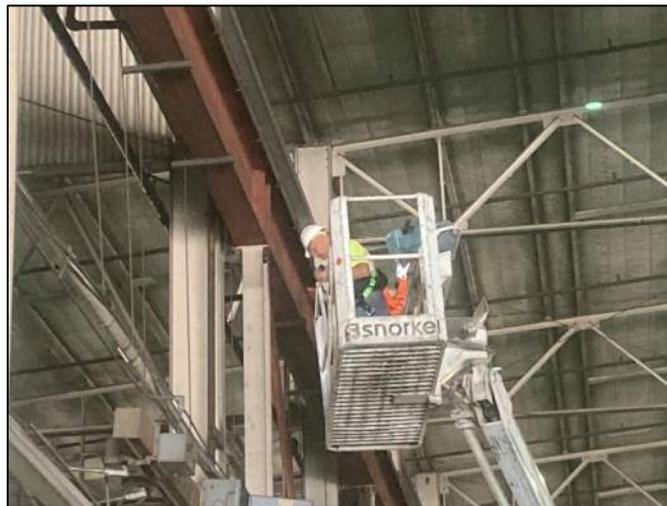
Figure 2 – View of inspection manlift

Figure 2 below shows typical inspection procedures utilizing the manlift. The Column Line inspections, both east and west, consisted of column lines 1 through 26. Some tops/columns and rail/beam sections were not inspected up close due to multiple access issues, steel coils, and/or equipment. The end sections were only visually inspected from a distance to the north (column lines 1 and 2) due to the crane in the parked or stationary condition. Each of the above areas was coordinated with POC project managers, on-site personnel and supervisors as needed.
